# Asset Health Engineering Justification Framework

## Multiple Occupancy Buildings & Complex Distribution Systems

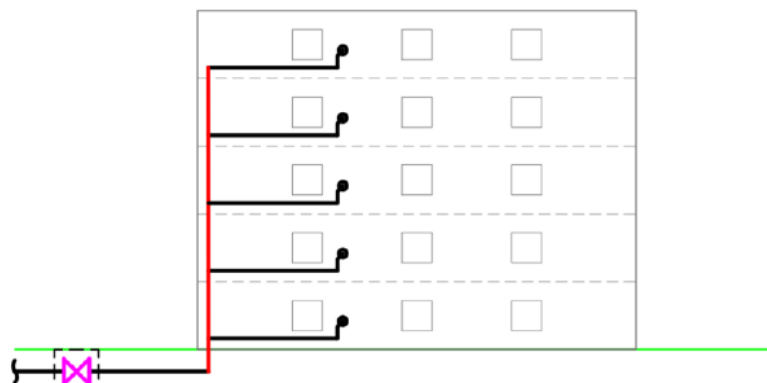
Risers are vertical and laterals are horizontal above ground pipes, supplying more than two end users within a single building, that are part of our distribution network. The gas supply is at low pressure (<70mbar) and MOBs and CDS sites are located across all regions of our network. Each riser must have a Pipeline Isolation Valve (PIV) in accordance with industry standard IGEM/G/5 Edition 3. Figure 1 below shows a schematic of a single riser system.

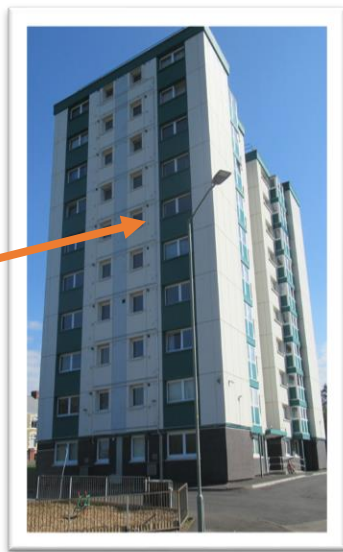
Figure 1: Schematic showing the gas supply to a MOB with a Pipeline Isolation Valve and the single vertical riser with laterals providing gas entries to individual apartments. There can be multiple risers on a MOB, figure 2 below shows some photographs of a multiple riser system on an MOB in our network which has been replaced with stainless steel.

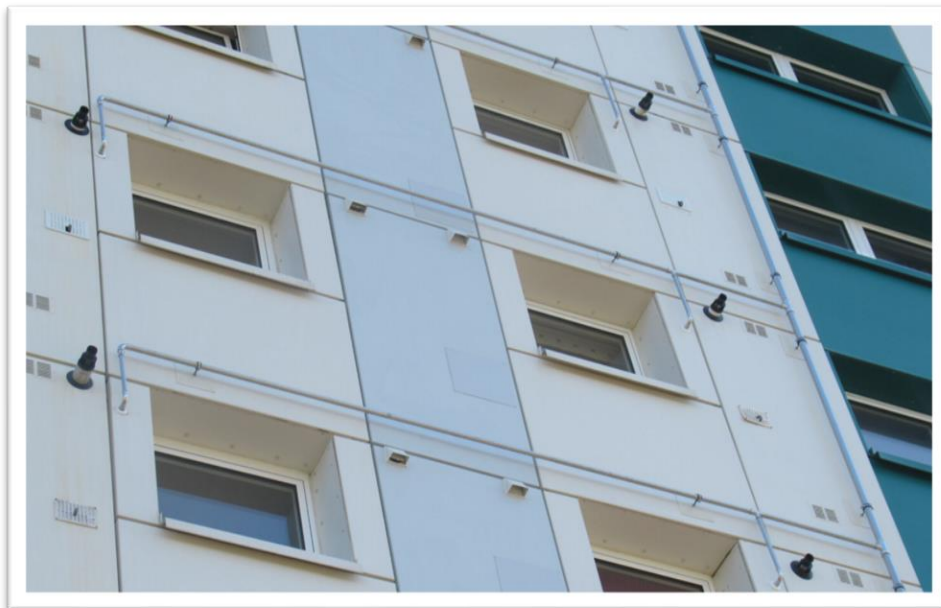
Close up of riser 1 and the laterals

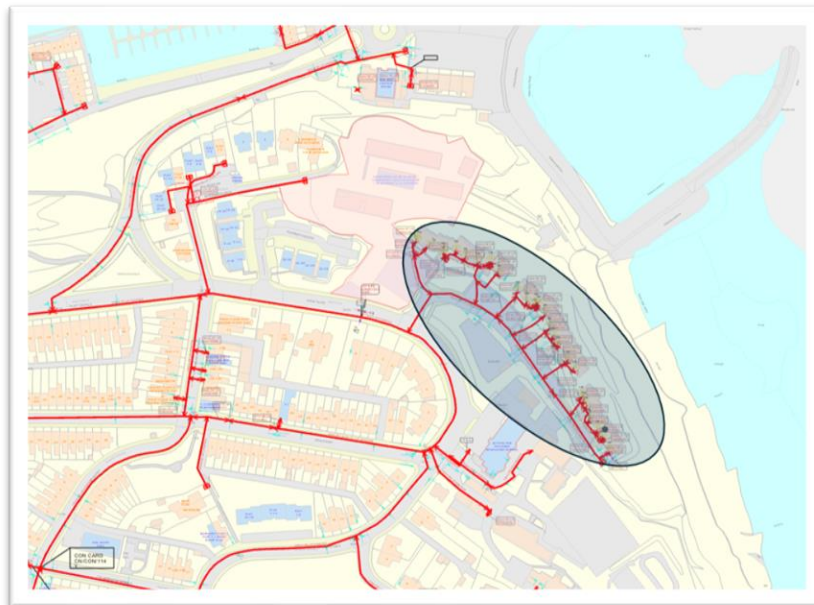
Figure 4: Northcliffe MOB, Penarth, Wales

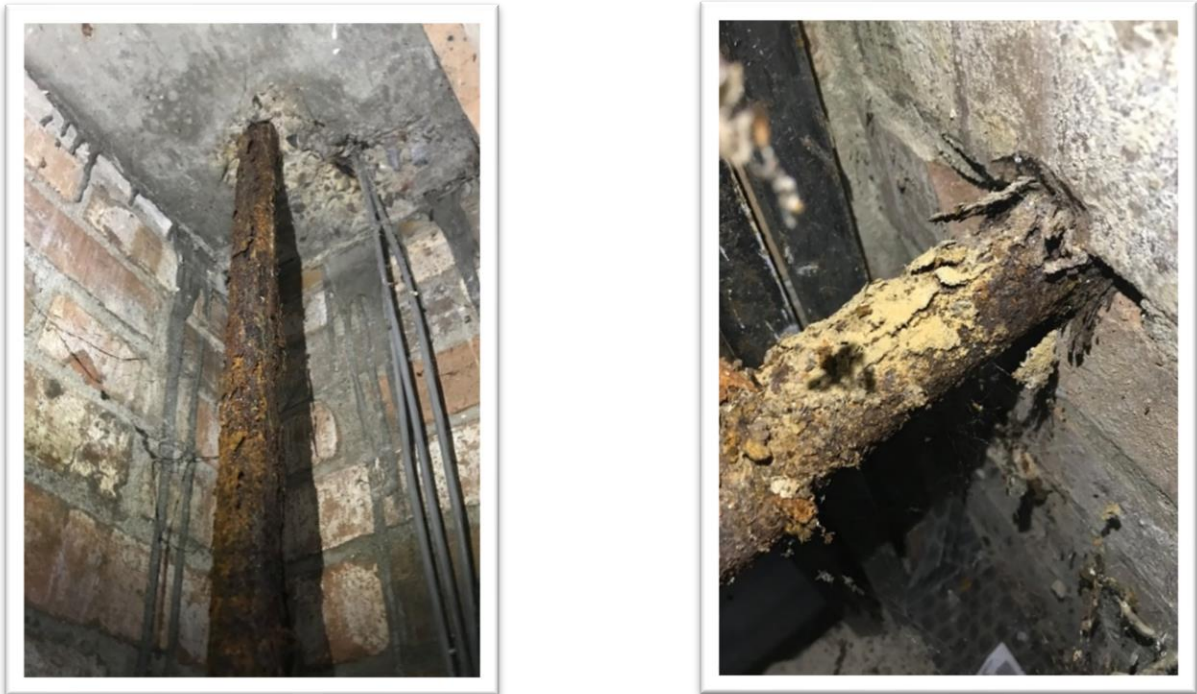
Figure 5: Photographs of corrosion at Northcliffe, Penarth, Wales

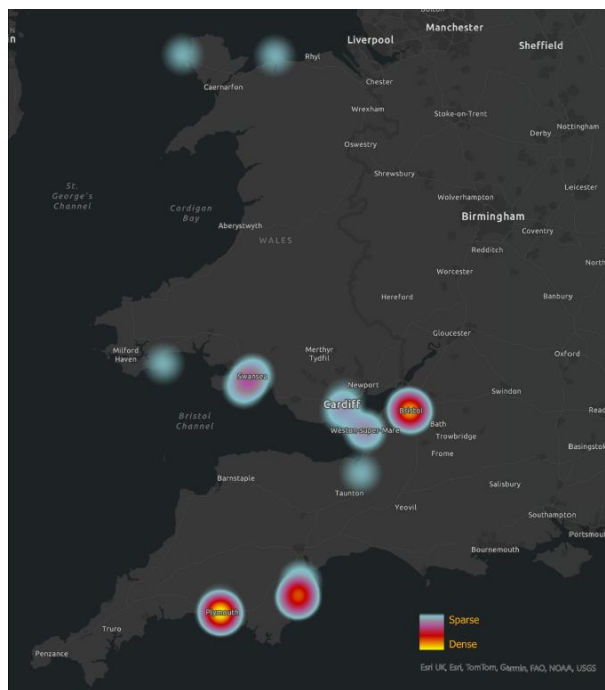
Figure 6: Distribution of High Rise (above) and low rise (below) MOBs in coastal areas of our network.

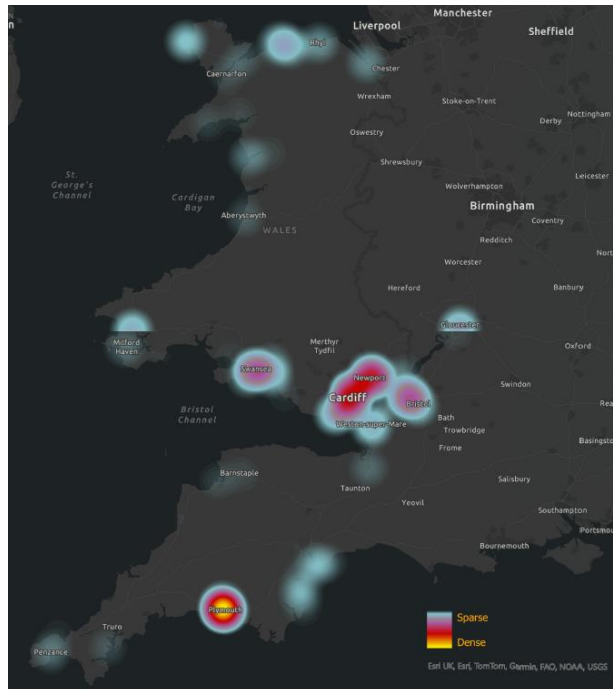
In addition to corrosion, we also need to invest in supports and fittings to ensure the riser is appropriately supported and cannot fail due to excessive movement of the pipes.

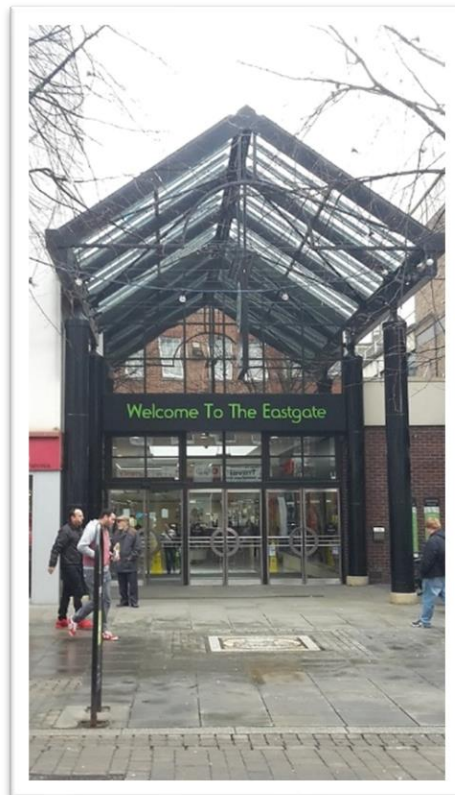
Figure 7: Eastgate Shopping Centre, Gloucester

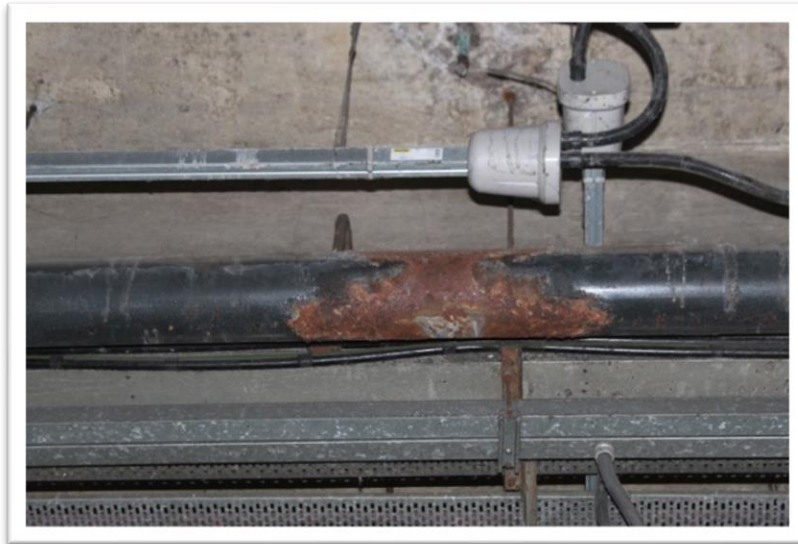
Figure 8: Lateral one with severe corrosion

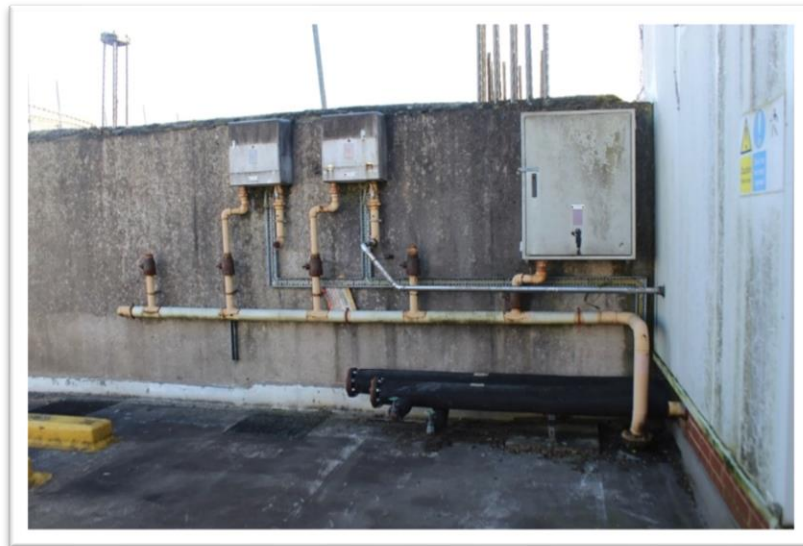
Figure 9: Manifold at Eastgate Shopping Centre

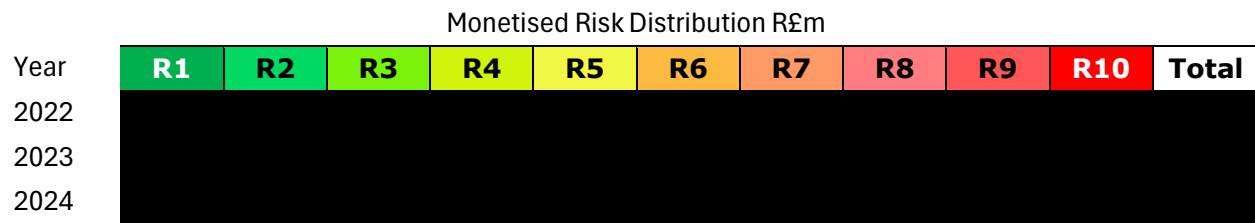
Figure 10: Risers removed from risk

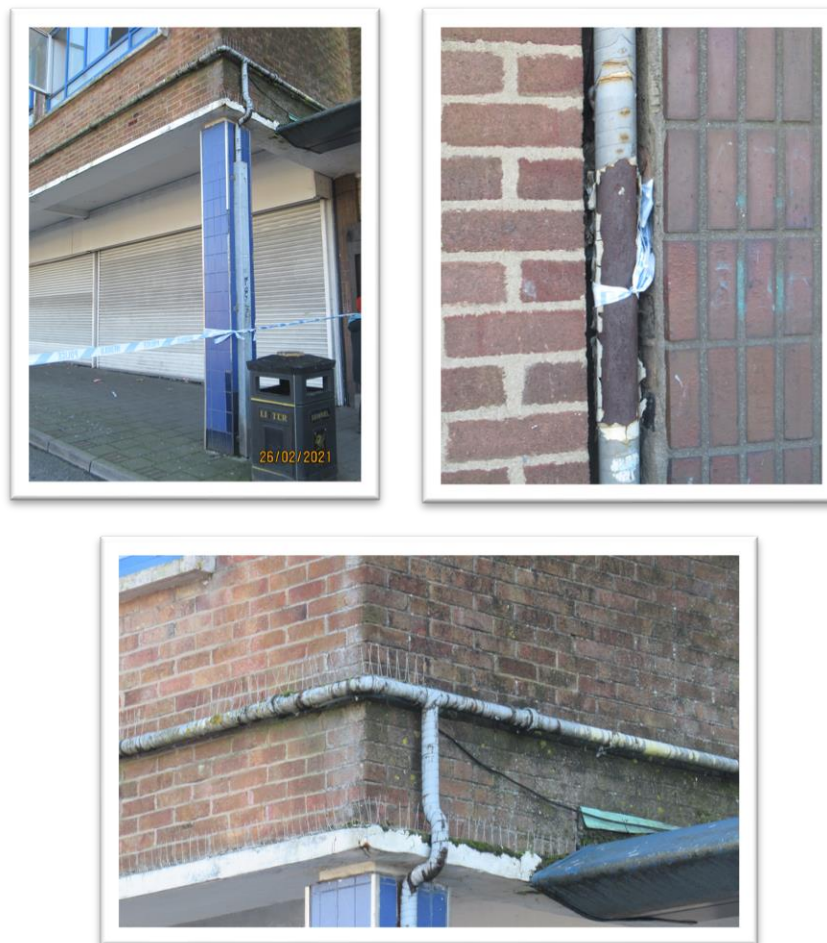
Figure 11a: Countisbury Avenue vertical riser on MOB before replacement

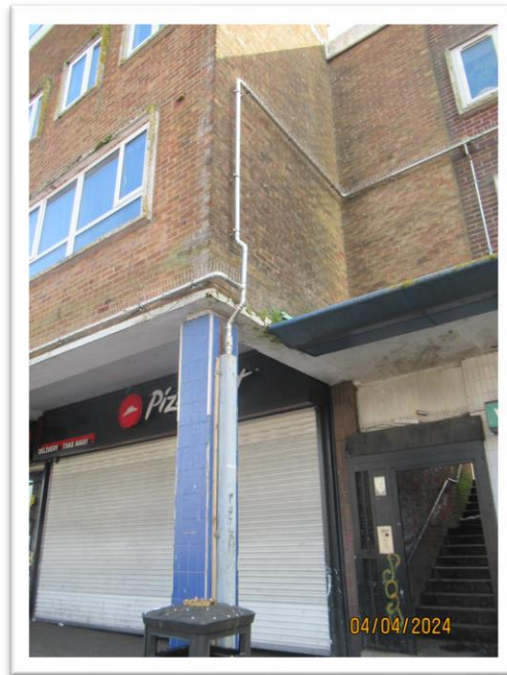
Figure 11b: Countisbury Avenue MOB after replacement (new vertical)

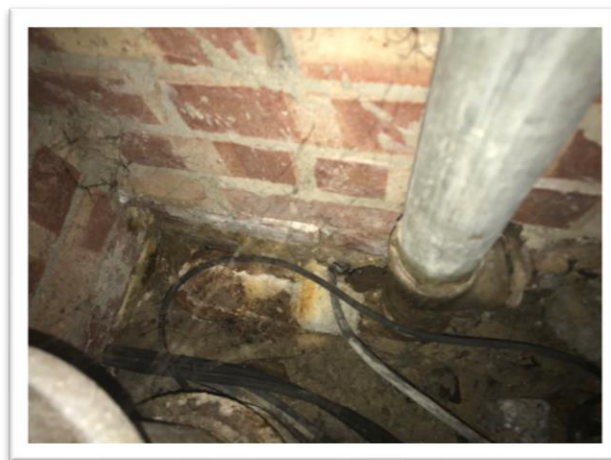
Figure 12: Hatherleigh Court, Swindon MOB Riser 1 before replacement

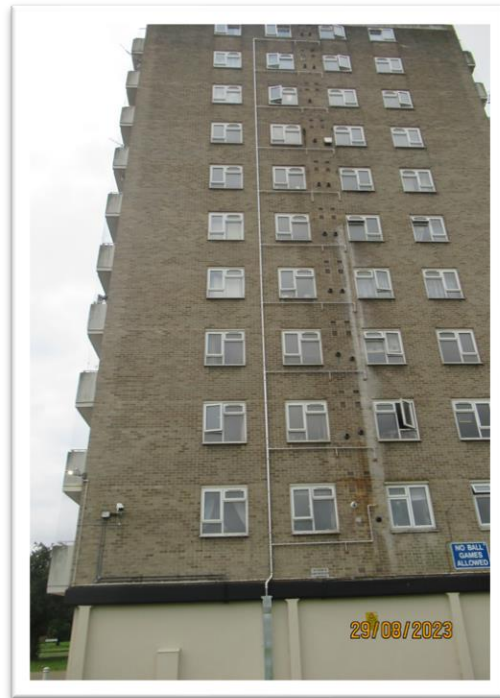
Figure 13: Hatherleigh Court, Swindon MOB Riser 1 after replacement

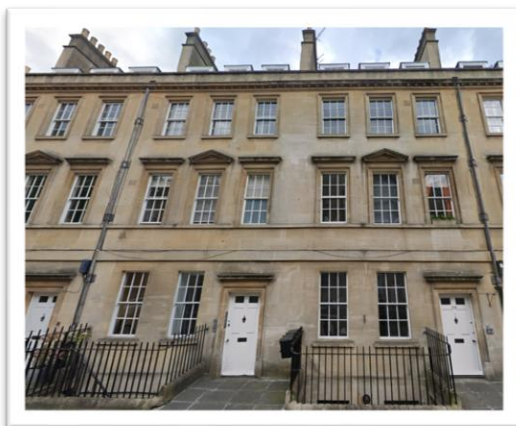
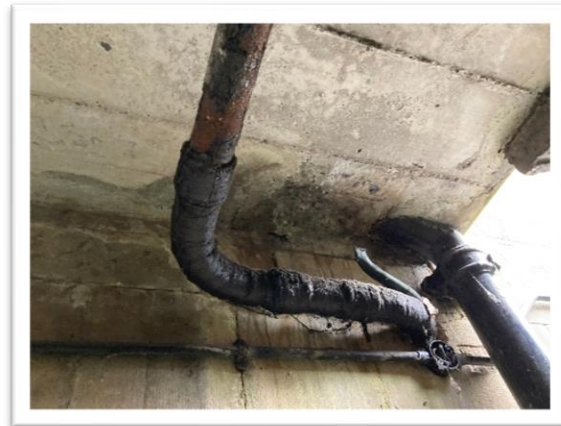
Figure 14: Photograph of The Paragon MOB in Bath and the location of the gas leak

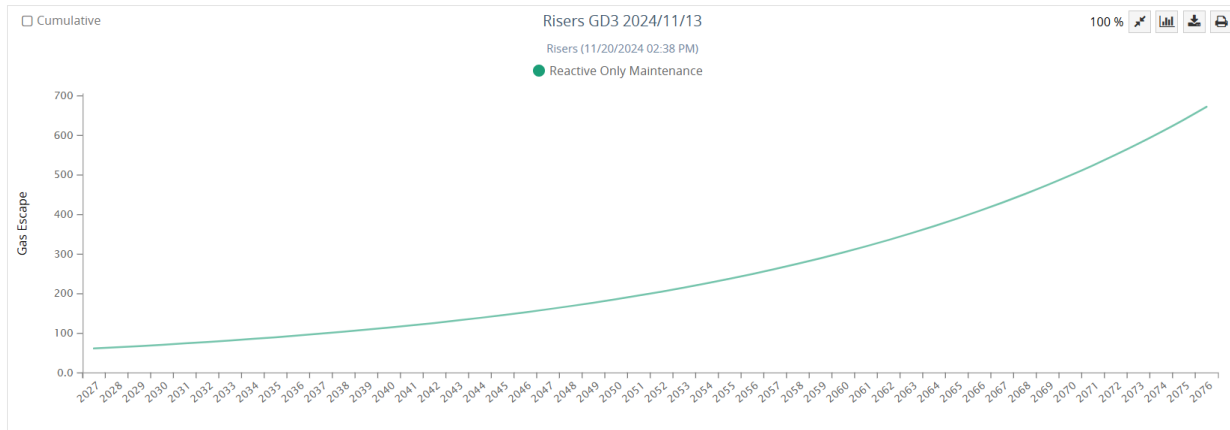
Figure 17: Gas escapes for risers without intervention

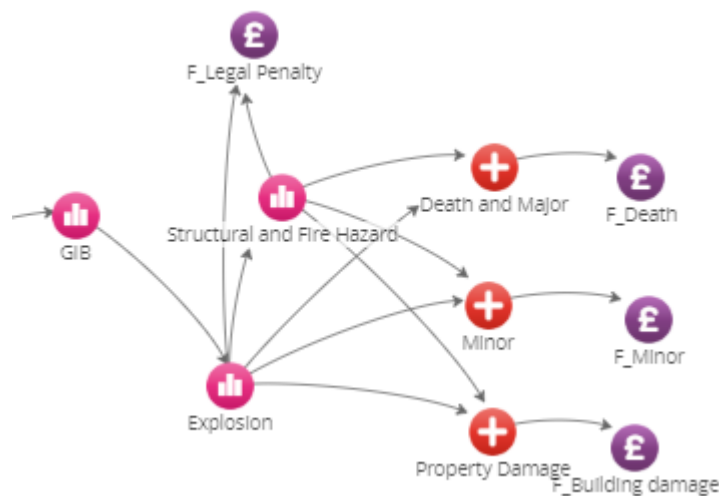
Figure 18: Consequences of failure

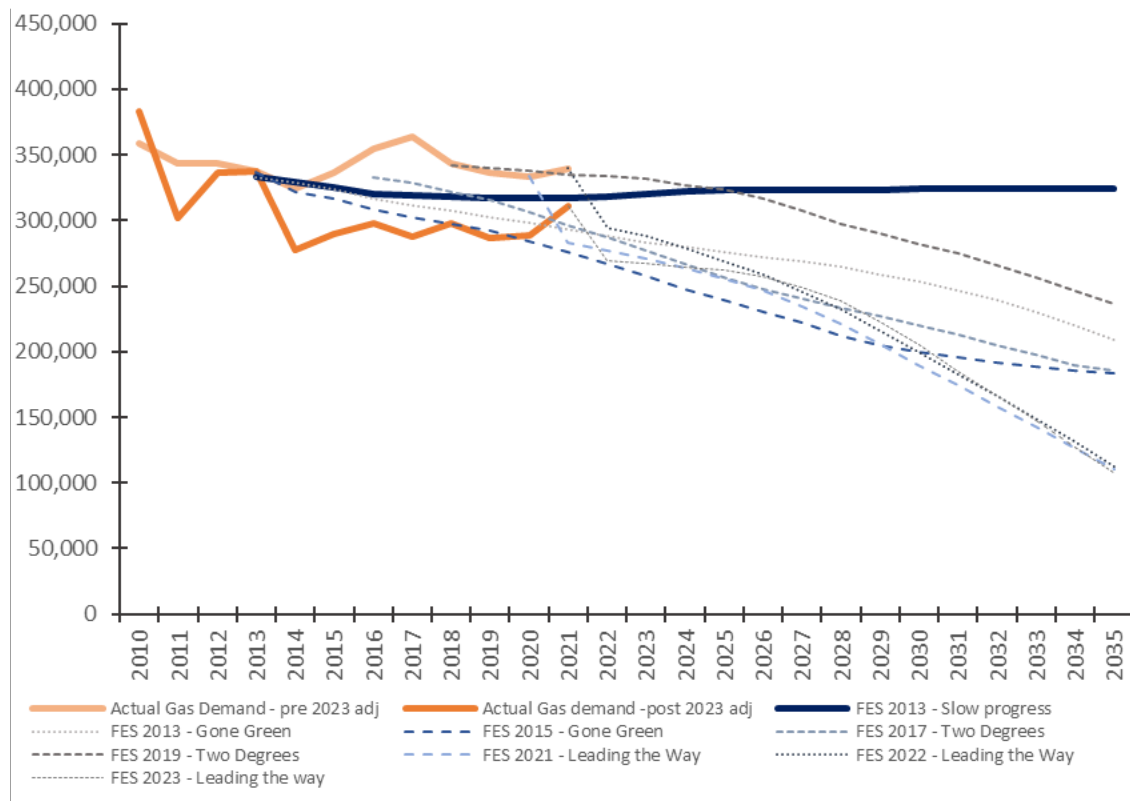
Figure 23: historical residential gas demand against the most optimistic scenario in every 2nd year of publication dating back to 2013

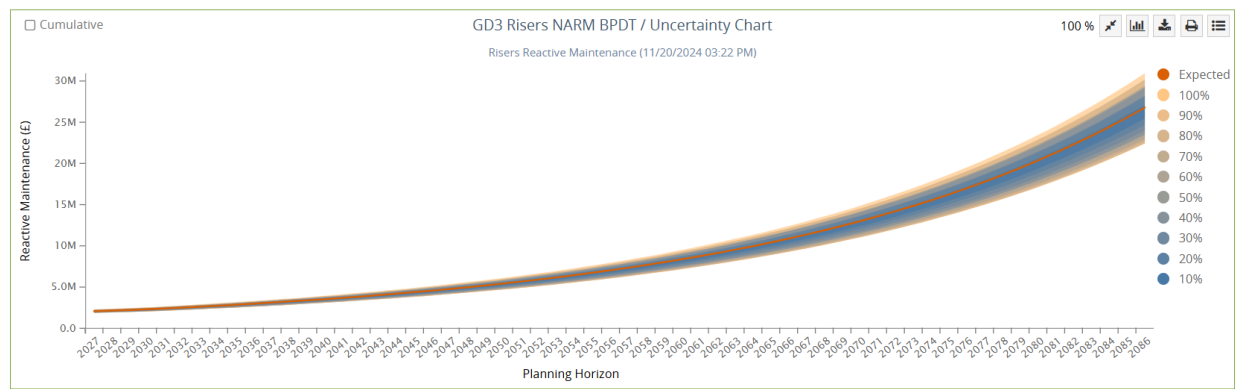
Figure 24: Chart to shows the confidence level in the robustness of our plan

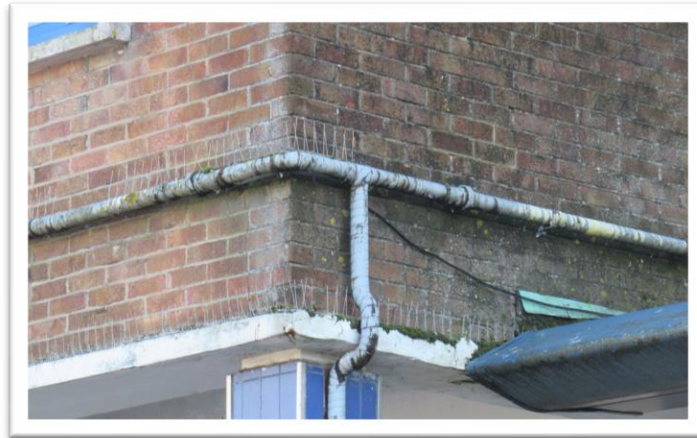
Figure 26: Countisbury Avenue vertical riser on MOB before replacement

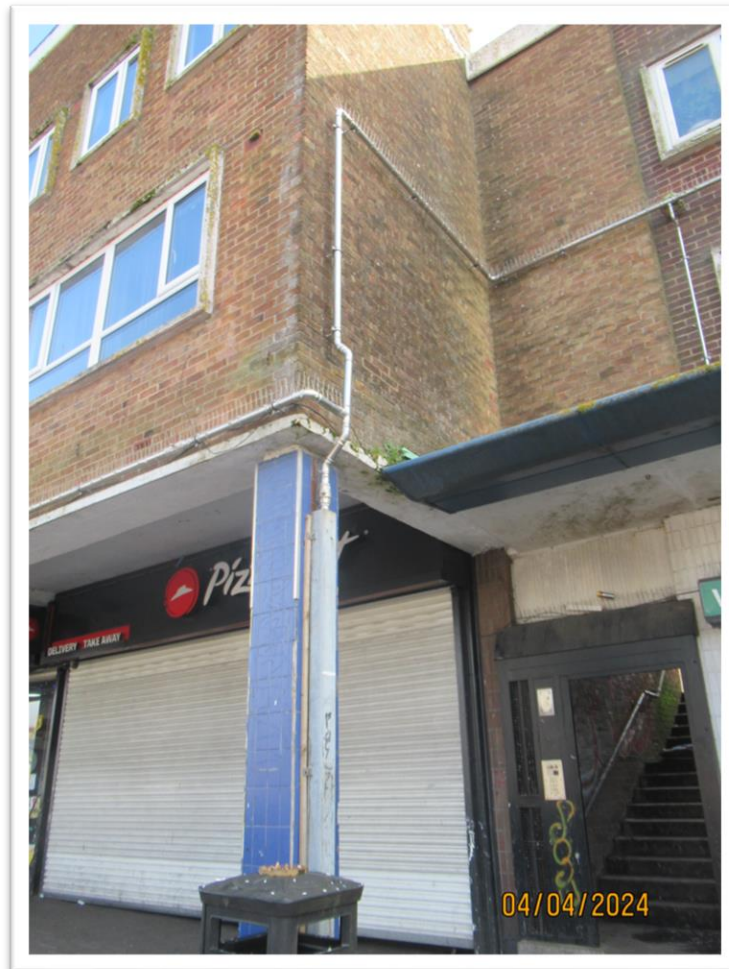
Figure 27: Countisbury Avenue MOB after replacement (new vertical)

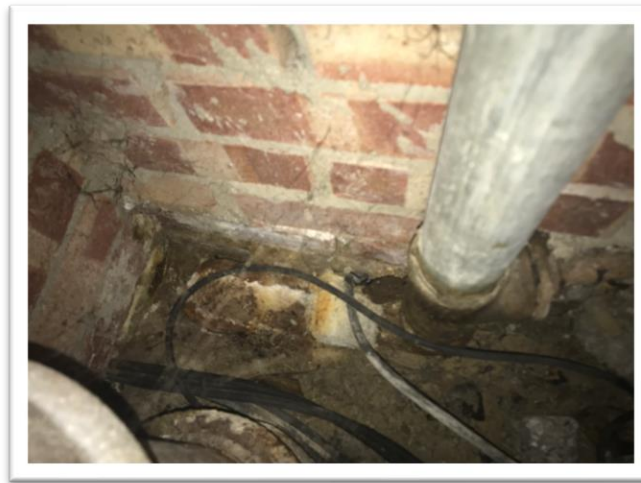
Figure 28: Hatherleigh Court, Swindon MOB Riser 1 before replacement

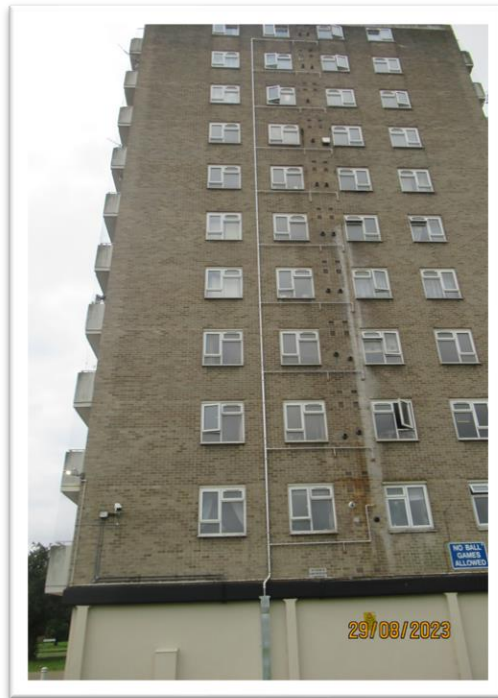
Figure 29: Hatherleigh Court, Swindon MOB Riser 1 after replacement

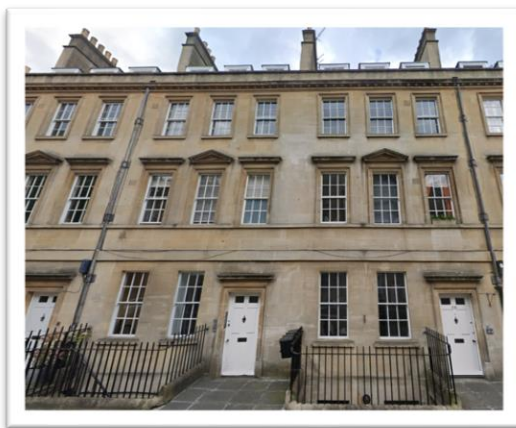
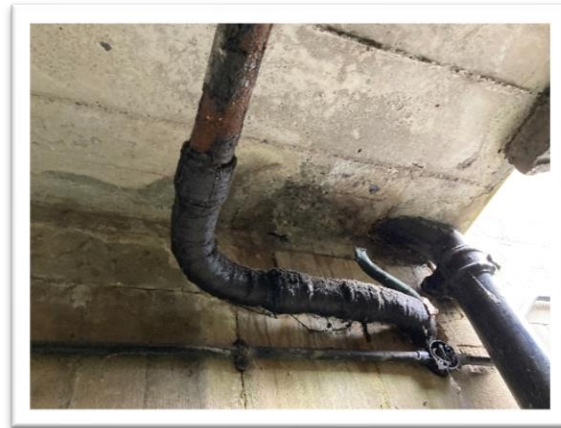
Figure 30: Photograph of The Paragon MOB in Bath and the location of the gas leak

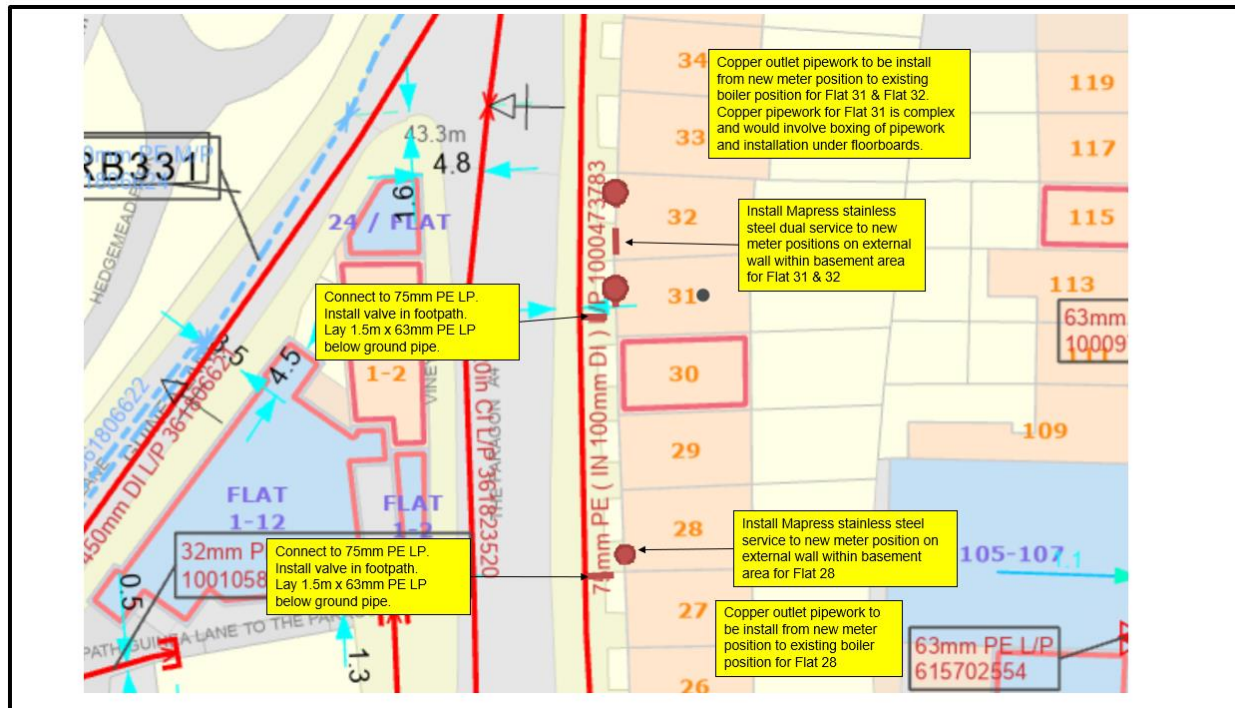
Figure 31: Maisonette design at The Paragon
